# Scientific Research

*Summary of Research Studies*

Argon K3Pro™  
Dental Implants

## Examining the K3Pro™ Osteoactive Surface<sup>1</sup>

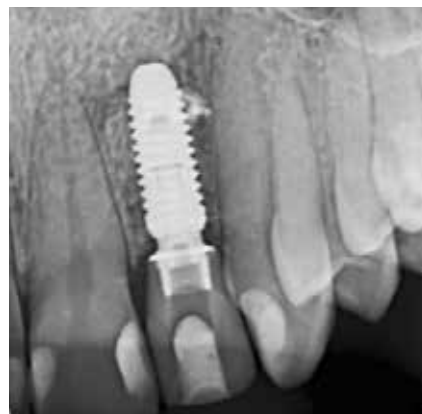
2015 - X-ray showing bone  
integration after 5 years

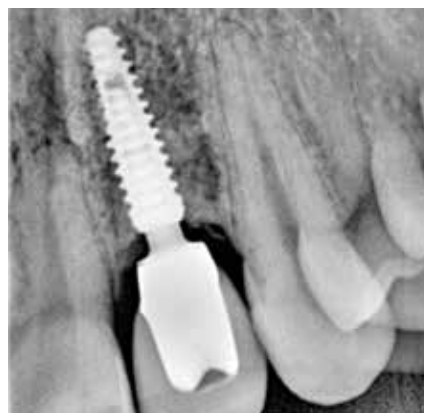
2017 - X-ray showing no bone loss after 4 years
